NATIONAL ADVISORY COMMITTEE FOR AERONAUTICS

REPORT 1363

ORIGIN AND PREVENTION OF CRASH FIRES IN TURBOJET AIRCRAFT

**Lewis Flight Propulsion Laboratory
Cleveland, Ohio**

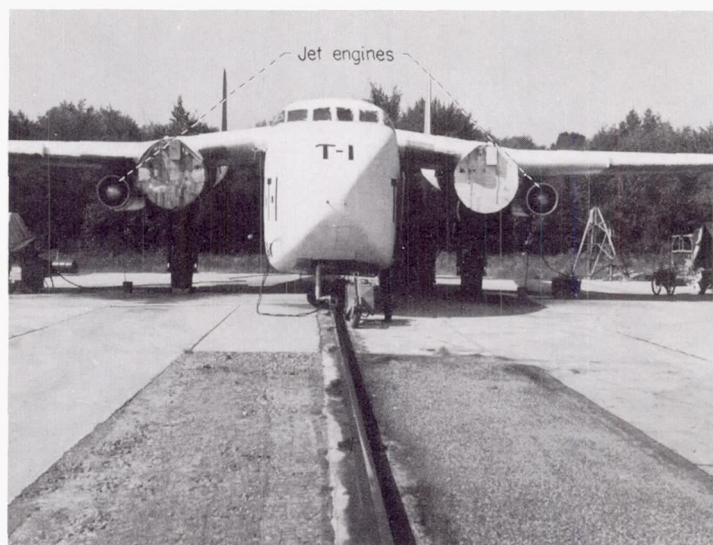
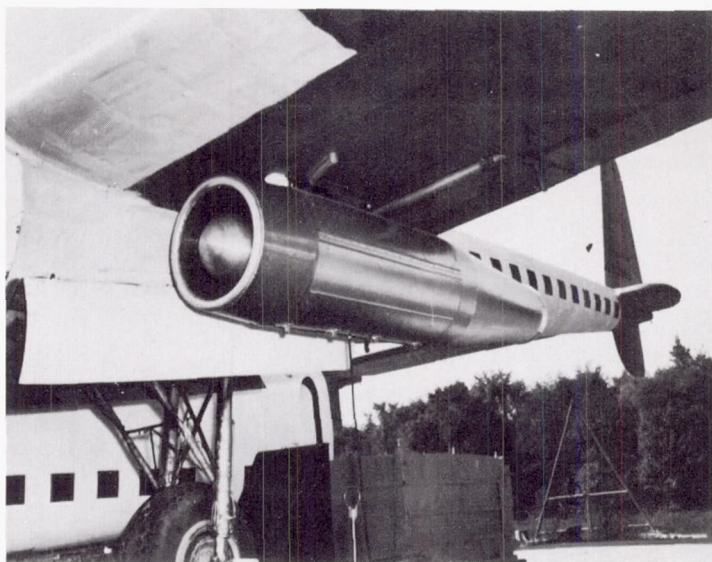
In order to observe how crash fires start with jet aircraft, two experimental full-scale crashes were conducted with turbojet aircraft having different engine installations. One of the aircraft was a C-82 airplane. The piston engines normally carried were replaced with either J35 or J47 engines, pylon-mounted to each wing to simulate a bomber-type engine installation. The airplane with turbojets is shown in figure 1. A fighter-type engine installation was

(a) Front view.
(b) Side view.

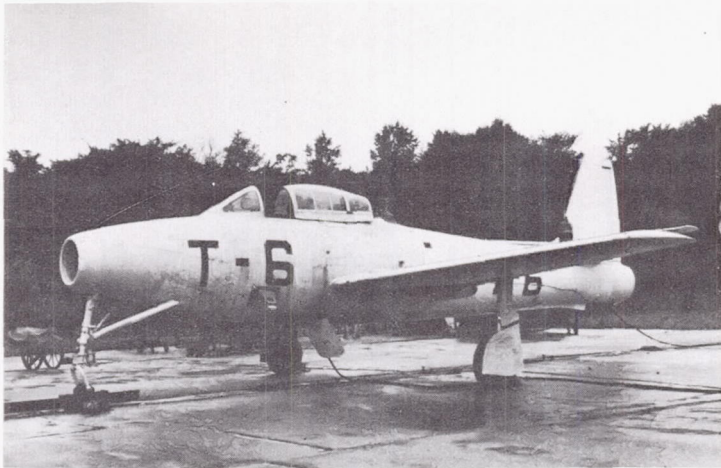
FIGURE 3.—F-84 Fighter airplane used in crash-fire investigation.

The F-84 fighter (fig. 3), carrying its turbojet submerged in the fuselage structure, caught fire in a similar crash. In this crash the fuel that entered the engine inlet was spilled from a fuselage tank adjacent to the engine-inlet duct. Arrangements for ensuring the failure of this tank in the crash are shown in figure 4. A driving strut was attached at one end to the nose wheel strut. The free end of the driving strut carried a spear-like tank cutter aimed at the fuselage fuel tank, whose wall is adjacent to that of the air duct. When the nose wheel strut failed rearward in crash, the driving strut cut the duct and tank walls. Fuel in liquid form poured into the air duct and was drawn into the engine.

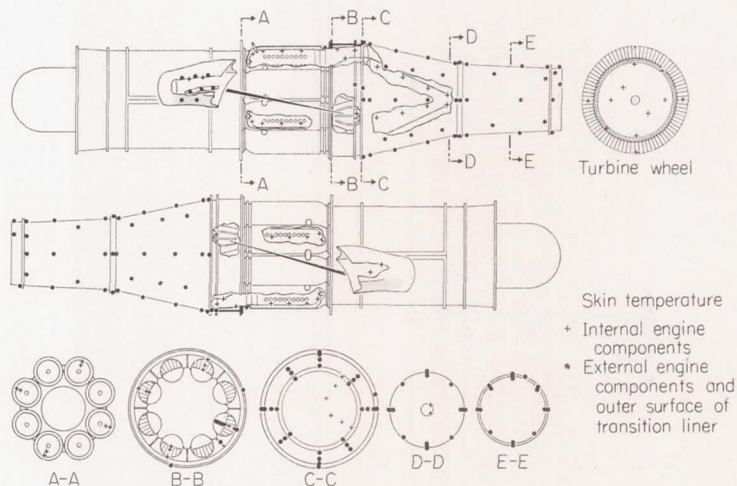
FIGURE 6.—Thermocouple locations on J47 engine.

Hot-metal surfaces.—If combustor fuel shutoff is provided upon crash and residual flames are avoided, the hot engine metal may be a potential ignitor. Consequently, the temperatures of characteristic engine parts downstream of the compressor were measured on test-stand engines at locations shown in figure 6 for a period following combustor fuel shutoff. Thermocouples reading temperatures on rotating engine

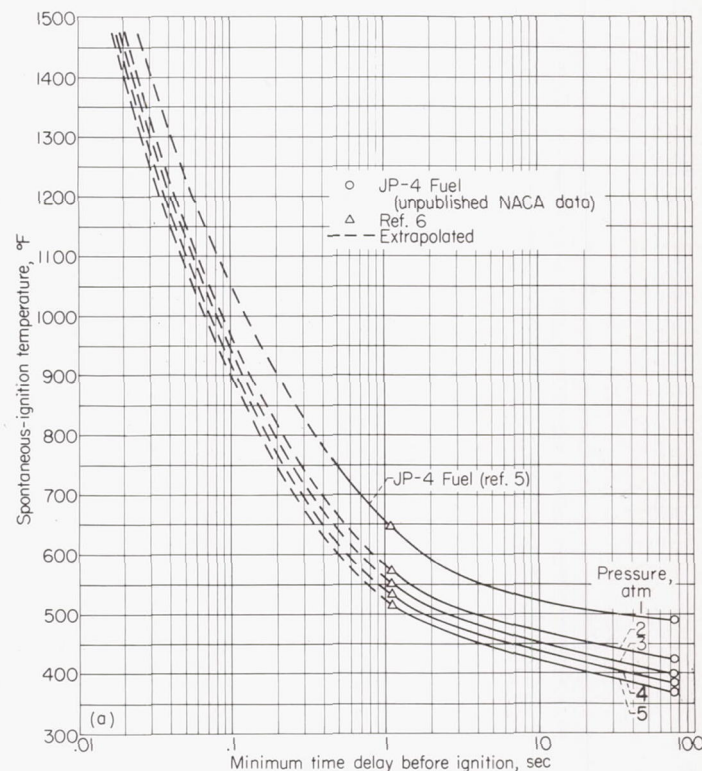
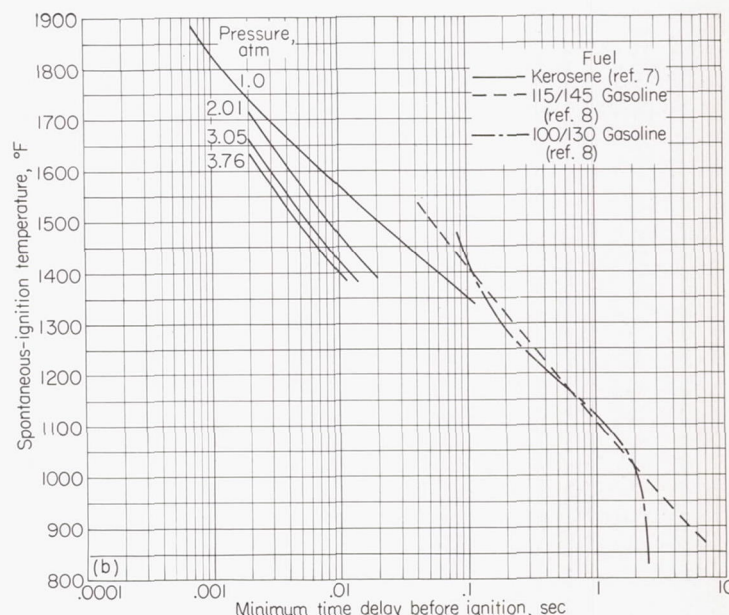
FIGURE 8.—Ignition characteristics of aviation fuels.

The corresponding curves for kerosene and 115/145 and 100/130 aviation gasolines (refs. 7 and 8) show the same trends as the curves for JP-4 fuel (fig. 8(b)). The fact that a contact time of more than 0.1 second is required to ignite a combustible atmosphere of JP-4 fuel on a 1000° F surface and a combustible atmosphere of gasoline on a 1400° F surface is important in the problem being investigated herein.

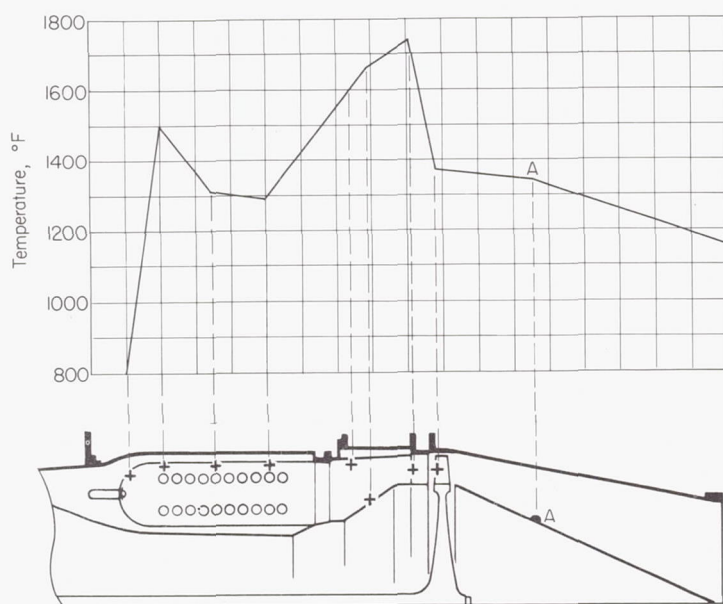
FIGURE 7.—Maximum temperatures of metal components in main gas stream of J47 and J35 engines.

The hottest parts of the engine, when operated at rated conditions, were those which lay in the main gas stream downstream of the compressor. The highest temperatures (fig. 7) were measured on the primary zone of the combustor liner, on the bend in the transition liner where the hot gases leaving the combustor impinge, and on the turbine-inlet guide vanes. Temperatures as high as 1660° and 1740° F were found on the transition liner and the adjacent turbine-inlet guide vanes, respectively. The stagnation gas temperature at the moving turbine blades was less than the stagnation temperature at stationary engine members in the same gas stream. The temperature of the blades was correspondingly lower, being about 1370° F for the hottest parts of the blade. The gases leaving the turbine were reduced in temperature because of the turbine work that had been done. Therefore, the temperature of the inner tailcone at location A in figure 7 was about 400° cooler than the turbine-inlet guide vanes. The temperature was about 1350° F at the hottest point of the inner cone and about 1150° F at its coolest point.

The largest temperature gradients occurred within the combustor (fig. 7) where some metal was in contact with the relatively cool combustor-inlet air and other metal was heated by the combustor flame. The maximum temperatures recorded were about 800° F on the dome, about 1500° F on the primary section of the combustor liner, and about 1300° F at the outlet. The lower temperatures at the combustor-liner outlet were produced by the cooler secondary combustor air.

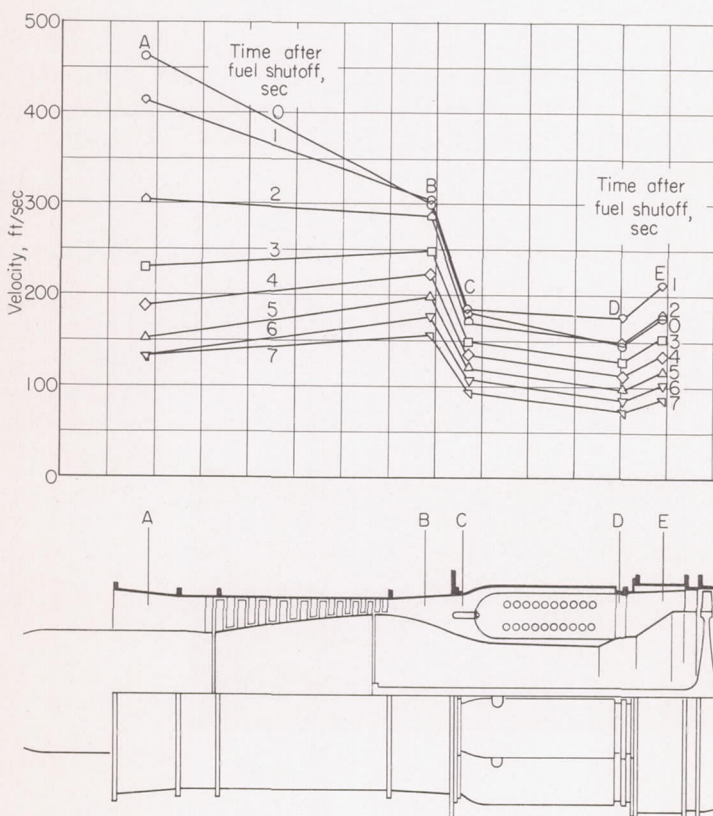
FIGURE 9.—Air velocity through J35 engine after combustor fuel shutoff.

A study of the gas velocity through the hot zones of the engine in the main gas stream showed that combustibles pass through these zones too rapidly to ignite. This is true for approximately 20 seconds following engine combustor fuel shutoff. After this period, the probability of fuel ingestion is quite low. The engine temperature and velocity data used in this study are discussed in appendix B for the J35 engine. In these studies the engine temperature and air velocity data provided in figures 9 and 10 were used. Similar studies which led to the same result were made for the J30 and J47 engines. The method of analysis discussed in appendix B provides a first appraisal of the possibility of ignition of ingested combustibles by components in the main gas stream.

engine and the engine geometry, the local air velocity through the engine upstream of the turbine inlet was plotted and appears in figure 9. Velocities were calculated only at the engine stations marked on the sketch. Each line connecting the symbols provides the velocity distribution through the

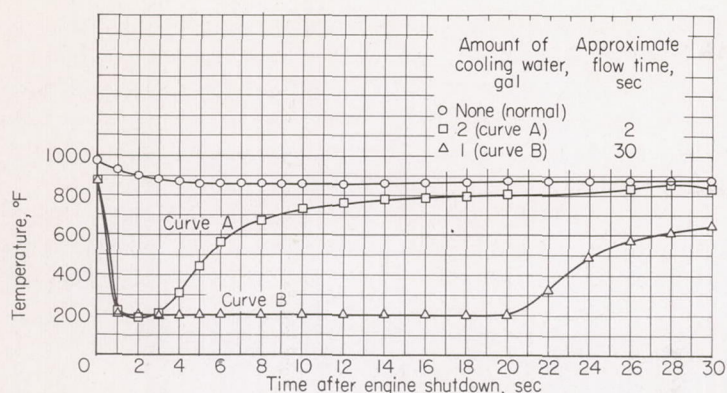
FIGURE 18.—Comparison of turbine-wheel cooling with short- and long-duration water sprays.

Because the turbine wheel had large mass and thickness, reheating of the wheel surface to unsafe temperatures occurred after the applied cooling water was expended. An example of the reheating of the hottest part of the wheel is shown in figure 18. In early experiments, when 2 gallons of water were sprayed over a 2-second period onto the aft

face of the turbine at the hub, the surface temperature dropped rapidly to the boiling temperature of water (curve A, fig. 18). Shortly after the water was expended, the surface of the wheel reheated by conduction from the hot interior. Unsafe temperatures above 600° F were established in less than 7 seconds. In order to avoid reheating to unsafe temperatures, the water discharge period was extended to 30 seconds. Experiments indicated that the quantity of water necessary could be reduced from 2 to 1 gallon for each face of the turbine disk. The wheel temperatures obtained are shown by curve B in figure 18. The time interval before reheating began was increased from 3 to 20 seconds. Reheating to temperatures above 600° F occurred after 27 seconds, at which time, however, the chance for fuel ingestion was remote.

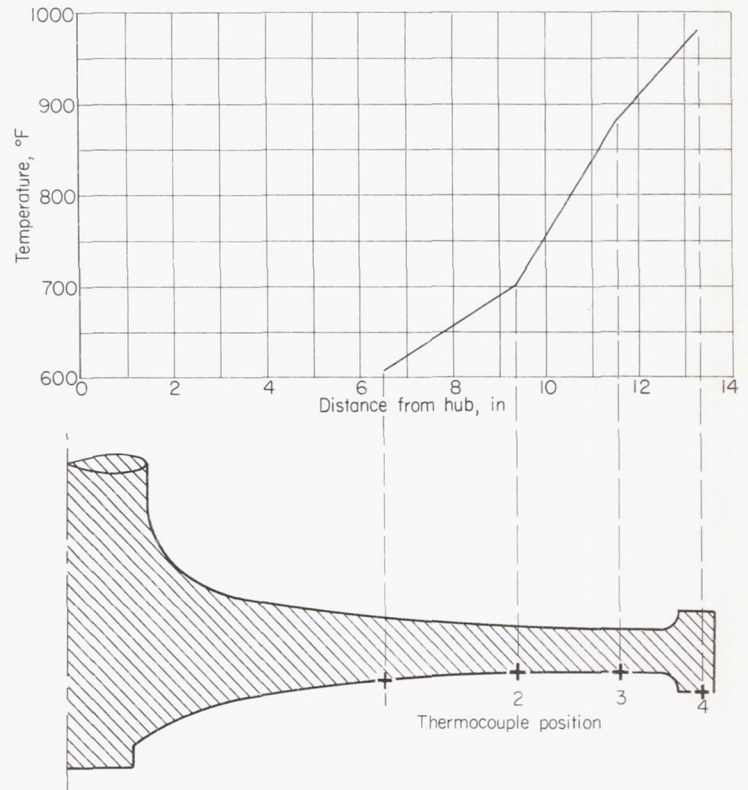
FIGURE 28.—Maximum temperatures recorded on J47-engine turbine wheel.

Engine parts not in the main gas stream were heated mostly by conduction. The turbine wheel was the most massive engine part heated this way. The radial variation in temperature on the surface of the turbine wheel, shown in figure 28, resulted from the fact that the heat conduction was from the wheel rim to the relatively cool hub. The data shown were obtained with the engine operating at rated sea-level conditions. The turbine-wheel surface temperature varied from approximately 980° F at the rim to about 605° F at a point midway between the rim and hub. Cooling air from the compressor applied to the hub to protect the engine bearings maintained this temperature pattern.

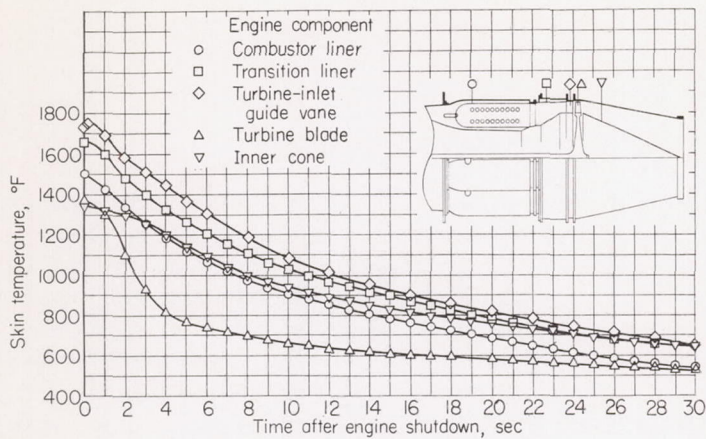
FIGURE 29.—History of maximum skin temperatures on engine components in main gas streams.

A history of the temperature of engine parts lying in the main gas stream is shown in figure 29. Fuel shutoff occurred at zero second, and the temperatures indicated were the maximum recorded anywhere on the component at the time noted. The hottest section of the combustion-chamber liner cooled from 1500° to 600° F in 24½ seconds. It took over 30 seconds for the transition-liner temperature to decline from 1660° to 600° F. In 30 seconds the turbine-inlet guide vane temperature dropped from a maximum temperature of 1750° to 645° F. The rotating turbine blade temperature fell from 1370° to 600° F in 16 seconds. Inner-cone skin temperatures declined from 1350° to 640° F in 30 seconds.

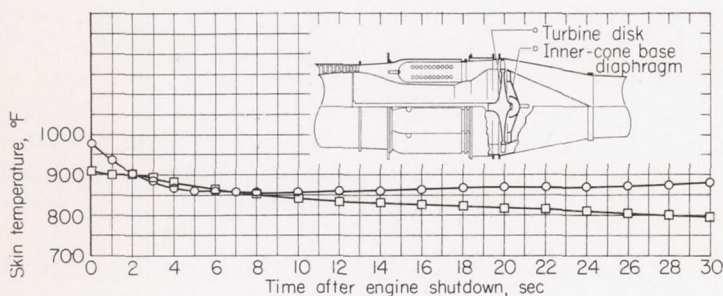
FIGURE 30.—History of maximum skin temperatures on turbine disk and inner-cone base diaphragm.

Engine parts not located in the main gas stream declined in temperature at much slower rates (fig. 30). The hottest part of the turbine wheel was initially at 980° F and dropped only 100° F in 30 seconds after fuel flow to the engine had stopped. The turbine wheel remained above the ignition

temperature of JP-4 fuel for 30 minutes after the engine was shut down. The large mass of the turbine disk contributed to its slow cooling rate. The inner-cone base diaphragm exhibited the same slow rate of cooling. Its maximum temperature was 910° F and cooled only approximately 115° F in 30 seconds.

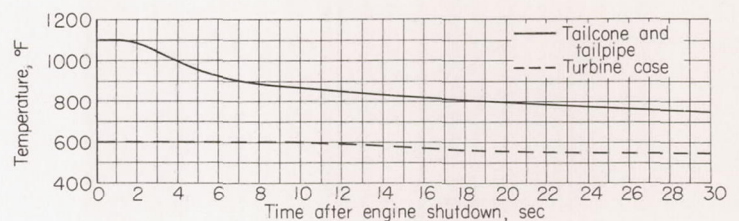
FIGURE 31.—History of maximum external skin temperatures on J47 turbine case and tailcone and tailpipe.

Temperature measurements made on the external skin of the J47 engine (fig. 31) indicated that the tailcone and tailpipe temperatures remained above 600° F for more than 30 seconds after the fuel to the combustor was shut off. Temperatures of the engine case upstream of the tailcone and tailpipe were usually below 600° F (fig. 32). Although the turbine case reached a maximum temperature of 600° F and remained so for 10 seconds after the fuel was shut off (fig. 31), no ignitions were experienced here.

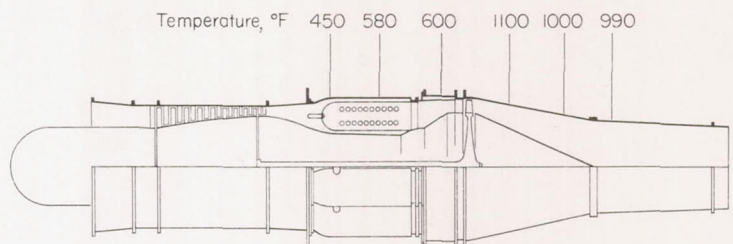
FIGURE 32.—Maximum external skin temperatures on J47 engine.

External surfaces of the tailcone and tailpipe were the only unsafe zones found in engines with compression ratios of 5 or less. Airplane combustibles that contact this section of the engine can ignite. In engines of higher compression ratios unsafe engine case temperatures may extend downstream from the last compressor stages. Temperatures must exceed 600° F for ignition to occur readily on the engine case, because it is moderately ventilated. This fact was established by many ignition trials on the external engine surfaces.

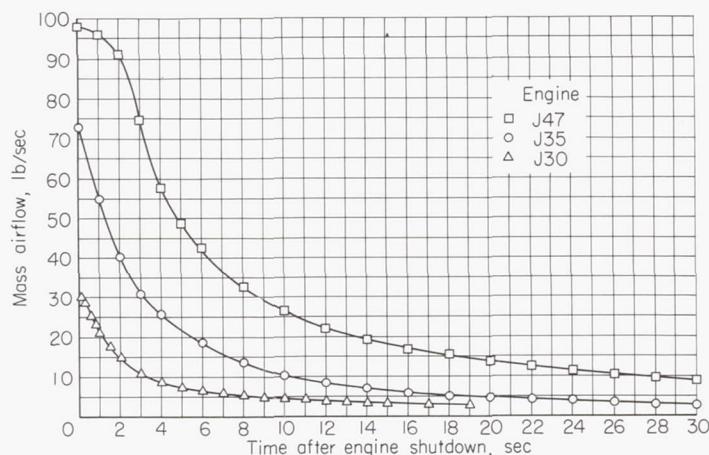
FIGURE 33.—Mass airflow after combustor fuel has been stopped.

The data on contact time required for ignition (fig. 8) can be used to obtain an approximation of the probability of hot-metal ignition of combustibles sucked into the engine inlet. The engine metal temperatures are known from the measurements given in figures 29 and 30. The contact time can be computed from the known mass airflow through the engine (fig. 33). From the airflow data for the J35

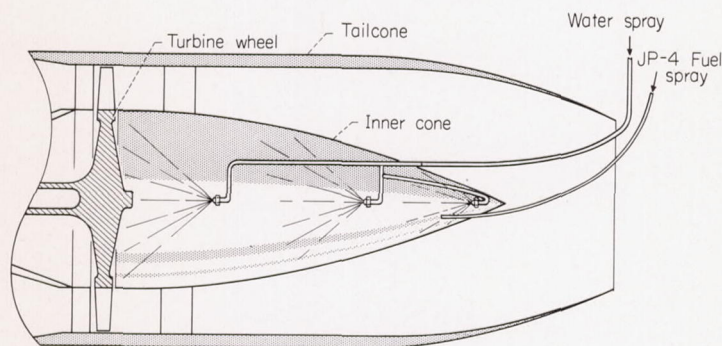
FIGURE 34.—Typical equipment used to study ignition hazard (J30 inner tailcone).

The engine cavity farthest downstream, the inner cone, was studied first. The arrangements used for the J30 tailcone are shown schematically in figure 34. A fuel system,

consisting of a single tube and nozzle, was arranged to spray fuel in measured quantities into the cavity of the inner cone to produce a combustible atmosphere. In addition, three water spray nozzles were installed facing the upstream direction. Since the J30 engine has no base diaphragm, the downstream face of the turbine wheel must be taken as a bounding surface of this cavity. The upstream water nozzle

Following this evaluation of the inner-cone interior as an ignition hazard the runs were repeated, but this time the water sprays were also turned on with the fuel spray in the inner cone. Initially, sufficient water was used to ensure absence of ignition. By progressively reducing the water quantity in repeated runs a minimum water requirement was established below which ignition would sometimes occur.
